EUROPEAN
COMMISSION

**on supporting the implementation of Directive 2009/148/EC on the protection of workers
from the risks related to exposure to asbestos at work as amended by Directive
2023/2668**

Guidelines for **managing asbestos related health and safety risks** at work

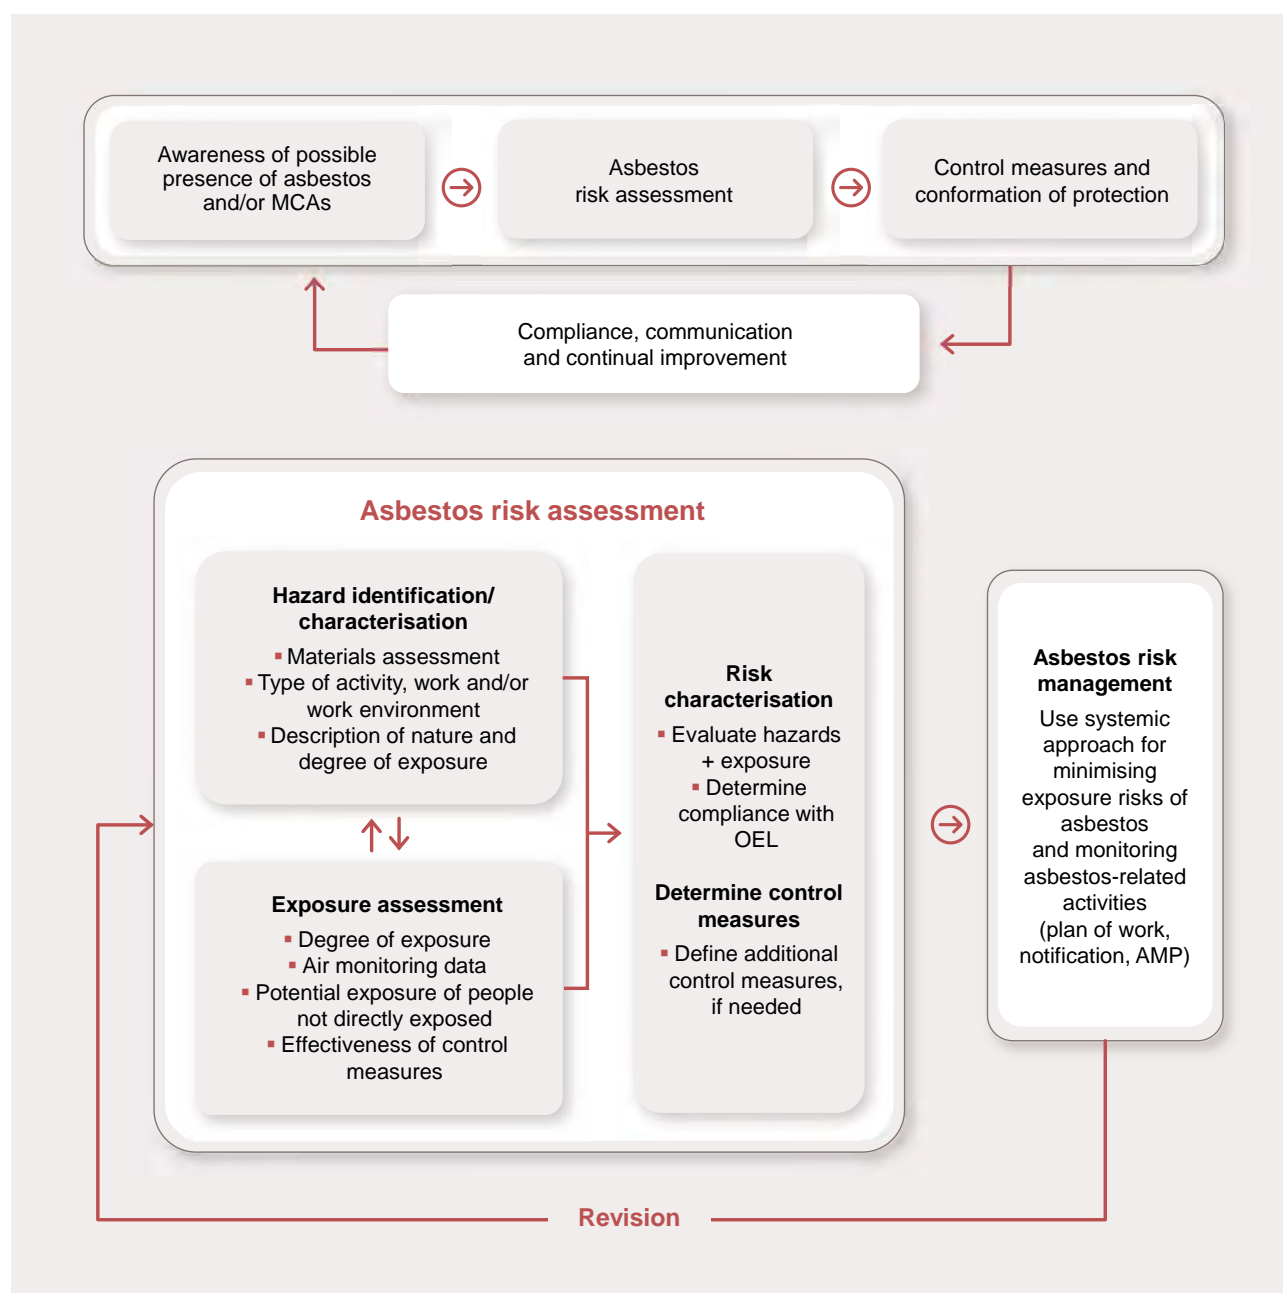
Figure 4-1: Illustrative role of an asbestos risk assessment within the overall approach to risk management

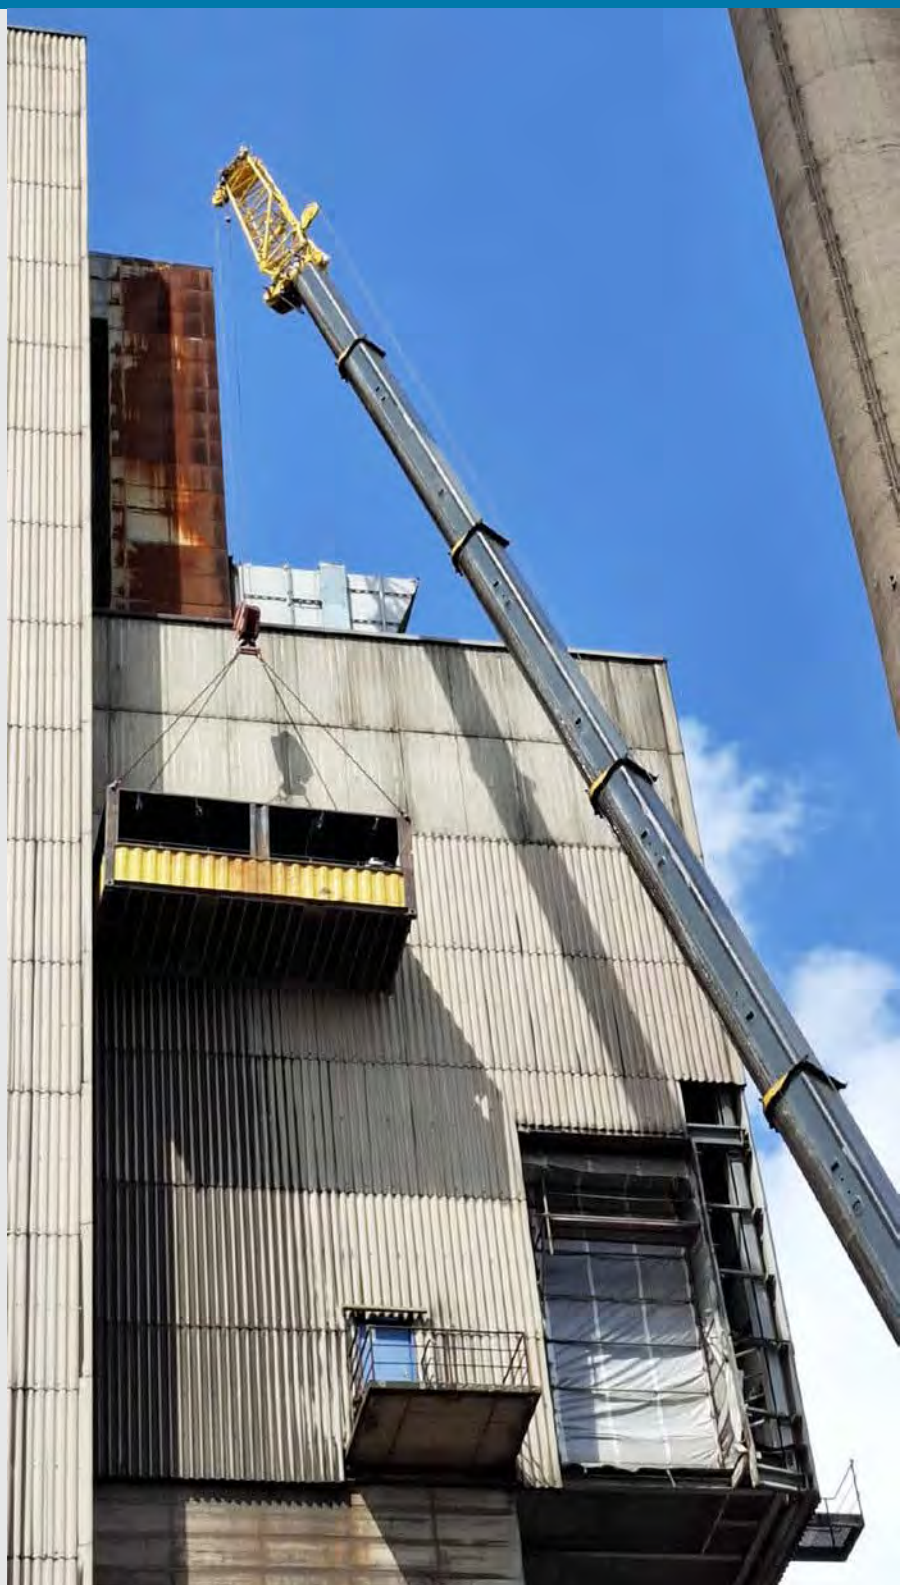
Figure 4-2: Example of the risk of working at heights during the removal of asbestos plates during the demolition of a power plant in Germany

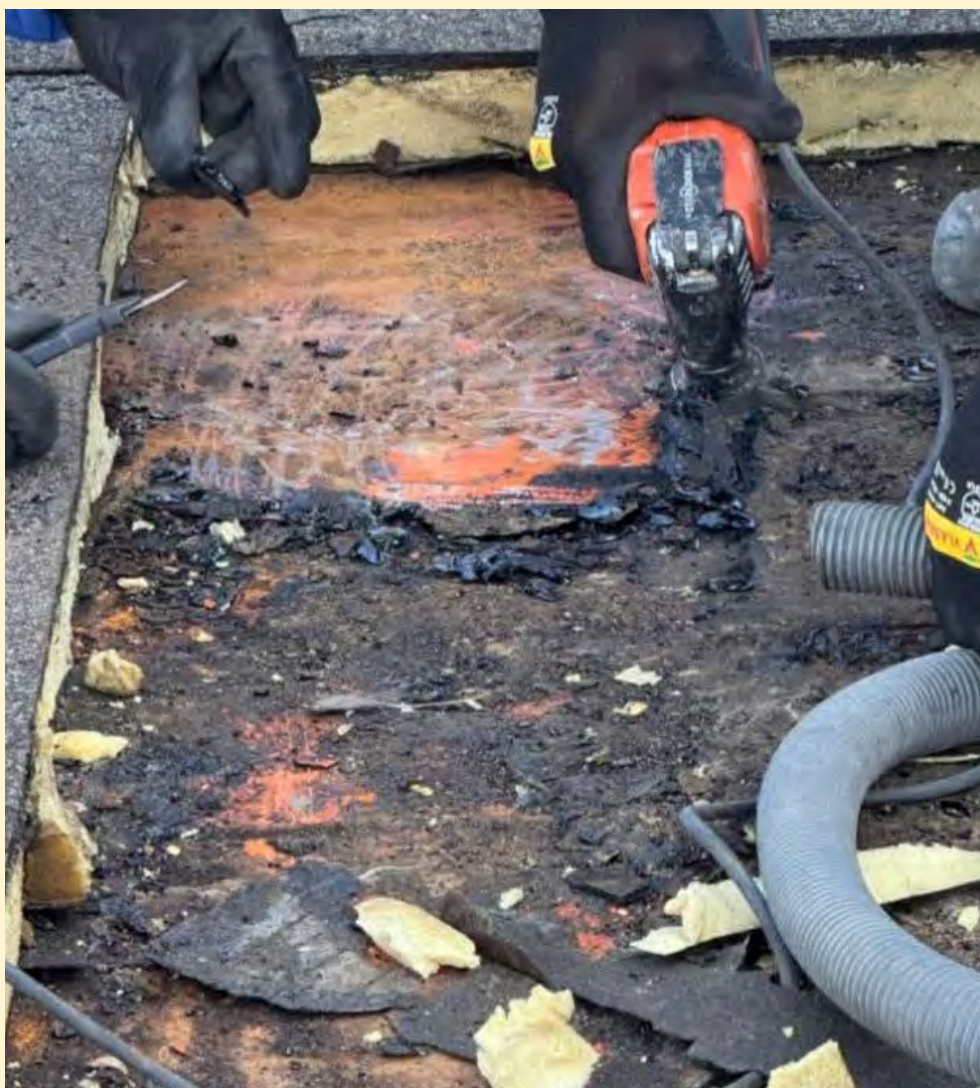
Figure 4-3: Removal of roofing materials containing asbestos, with metal supportive roof visible

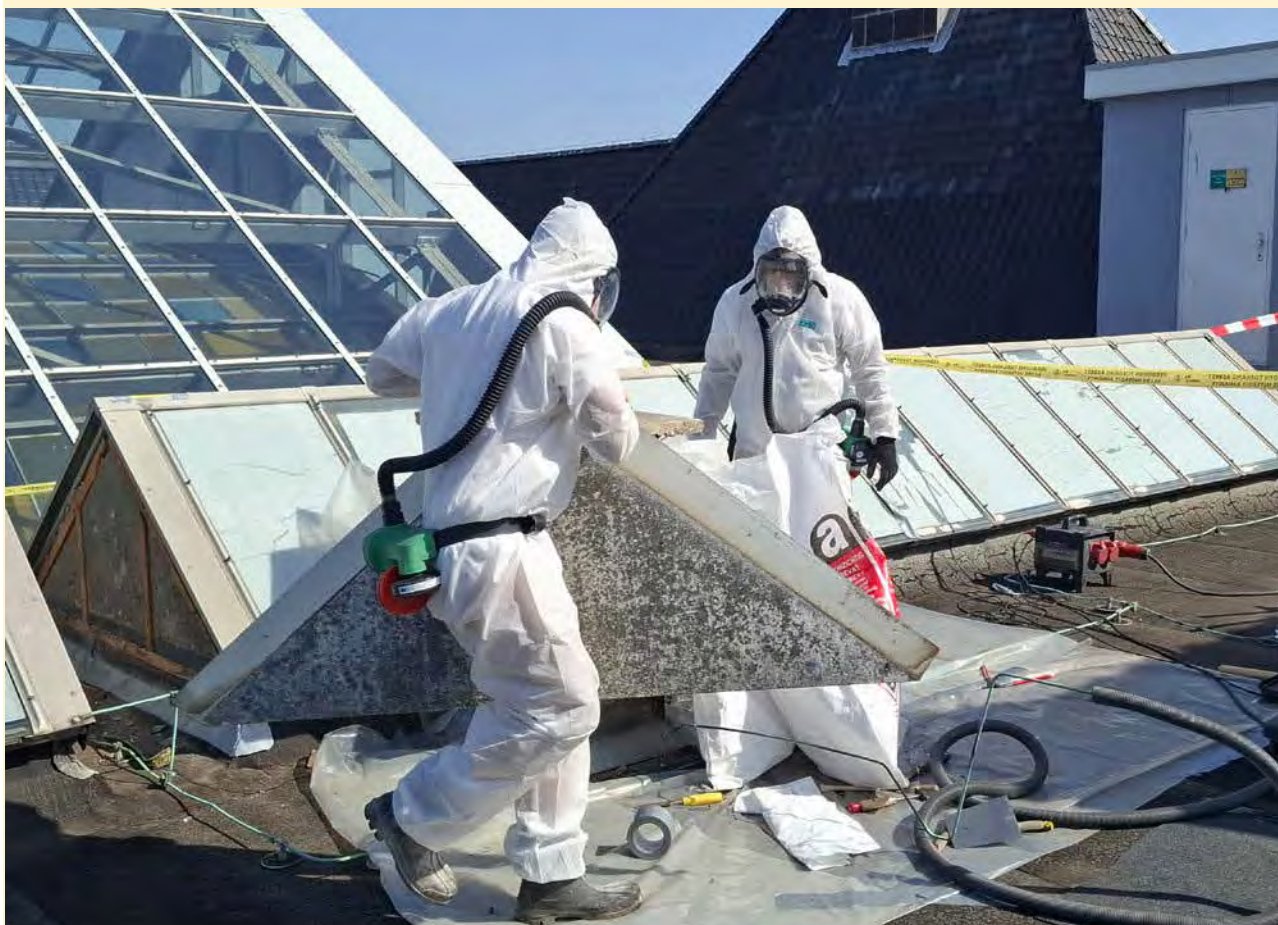
Figure 4-4: Workers removing asbestos plates on the roof

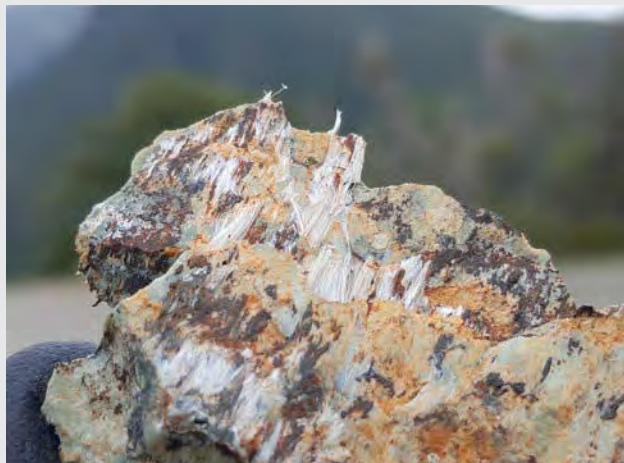
Figure 5-3: Chrysotile plated on serpentinites (France)

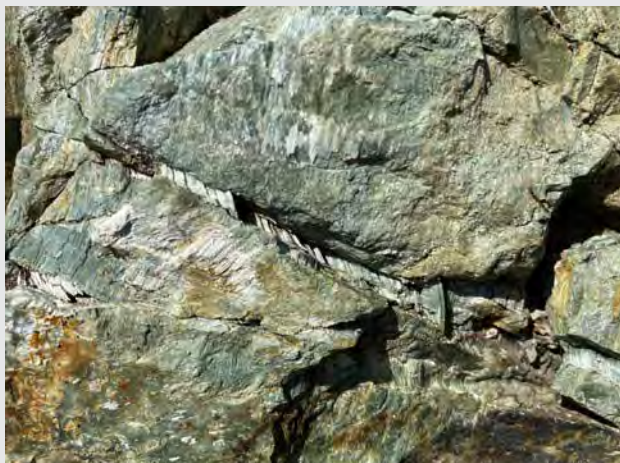
Figure 5-4: Chrysotile cross-vein in serpentinites (France)

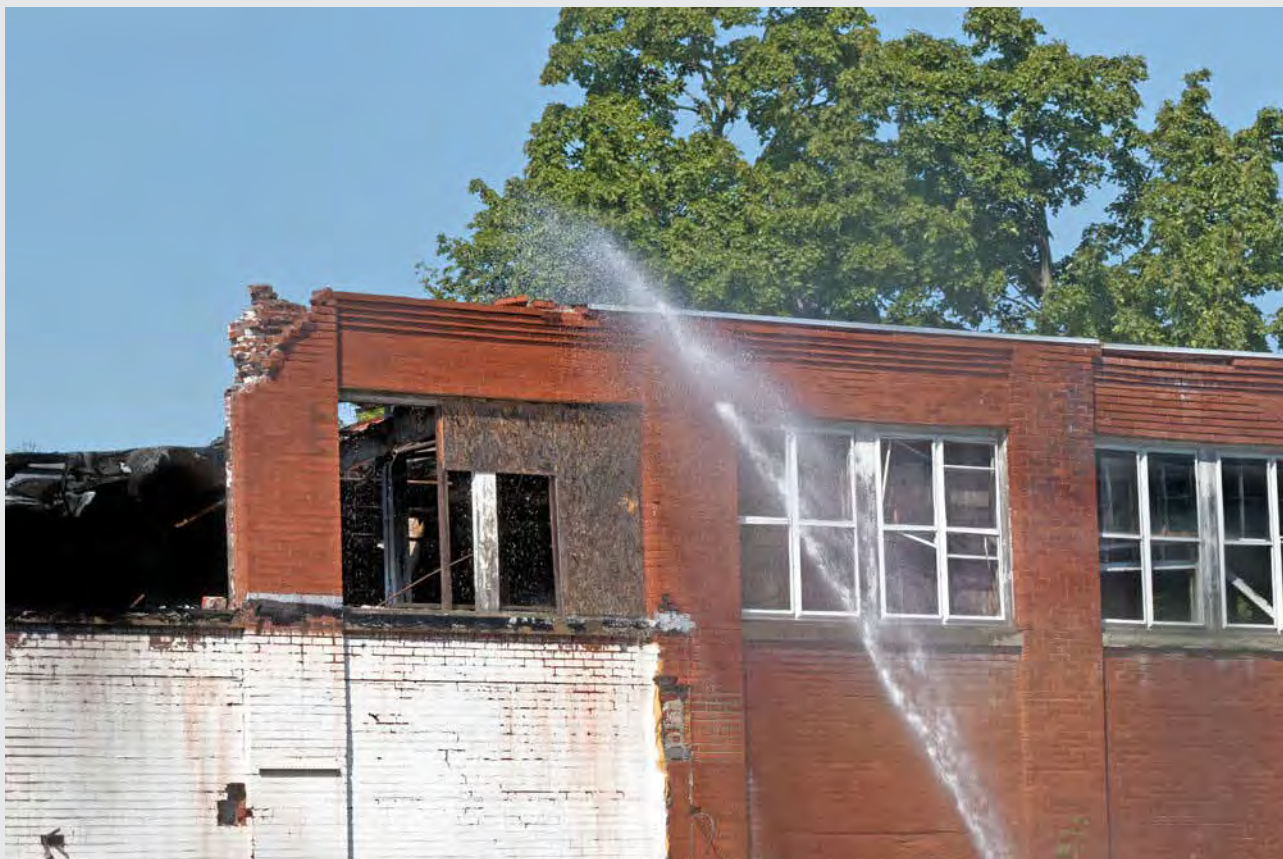
Figure 8-1: Example of wetting a building containing asbestos

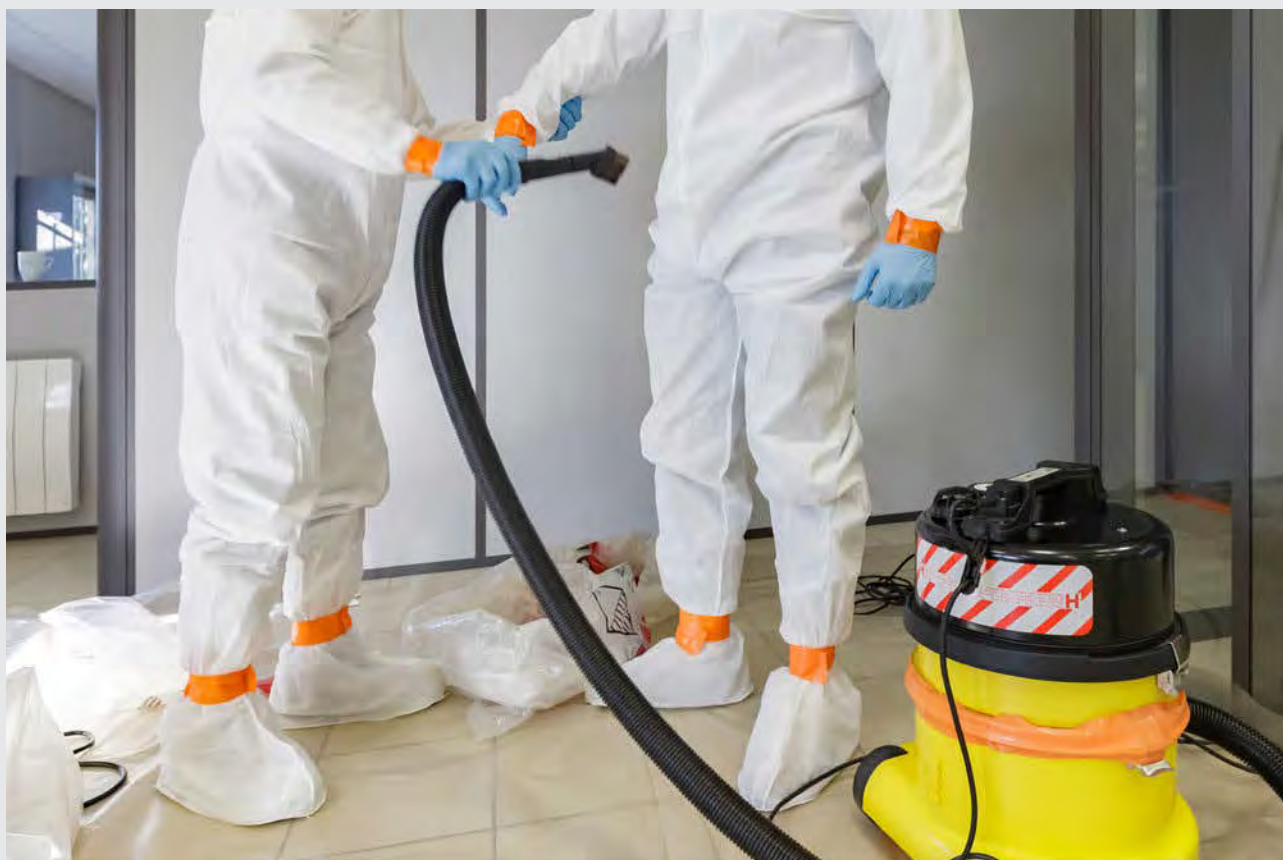
Figure 8-6: Example of cleaning using a vacuum cleaner

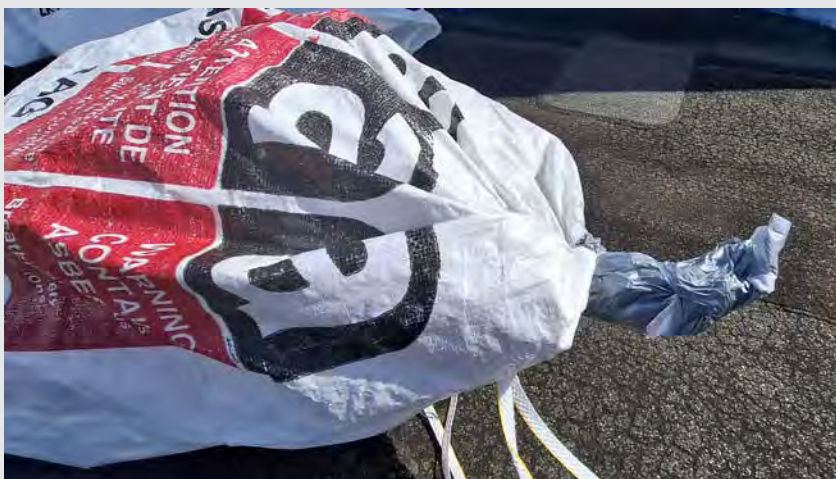
Figure 8-7: Image of a WCA bag tied with a gooseneck closure

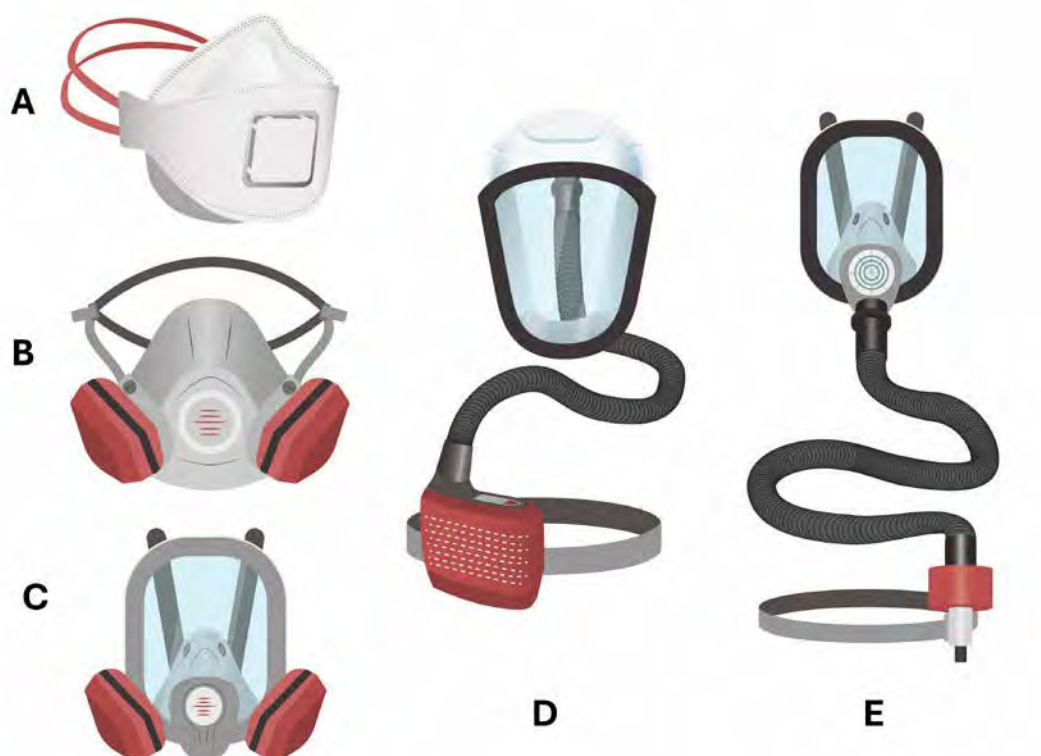
Box 8-8: Examples of RPDs and correct use**Figure 8-9: Examples of respiratory protective devices**

A: Filtering half-mask with valve (FFP3)

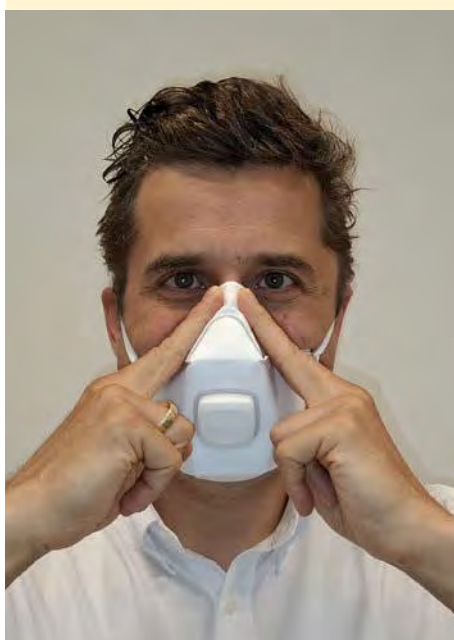
Figure 8-10:
Ensuring a proper seal

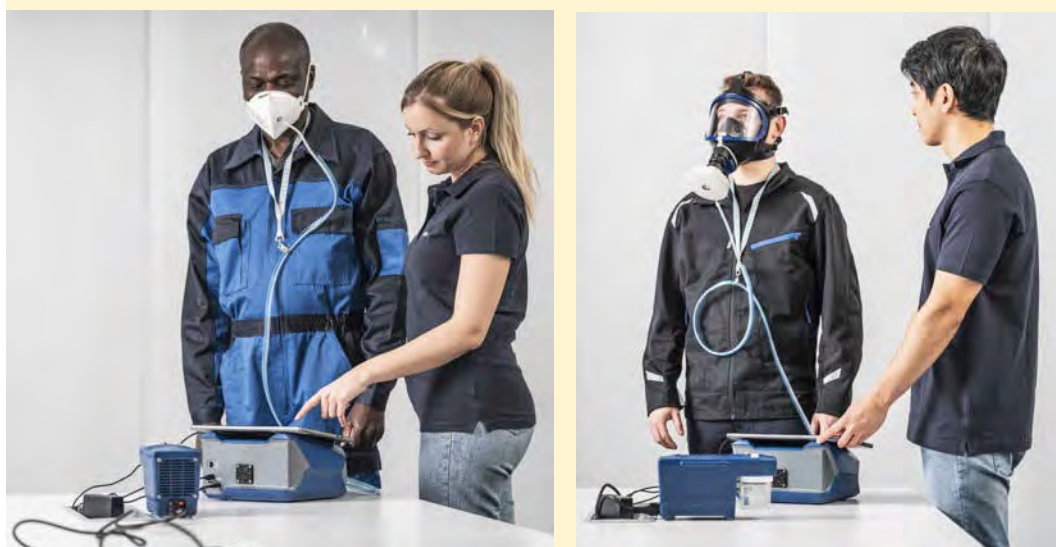
Figure 8-12: Examples of face-fit testing for full face mask and filtering facepiece

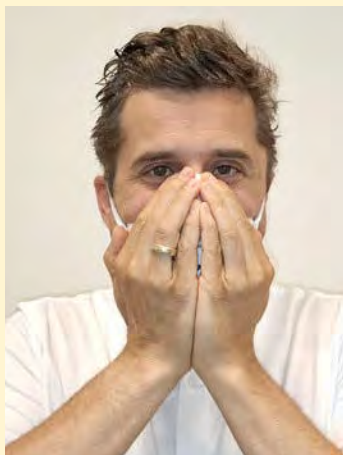
Figure 8-13: Pre-use check for leakages for an FFP3 mask

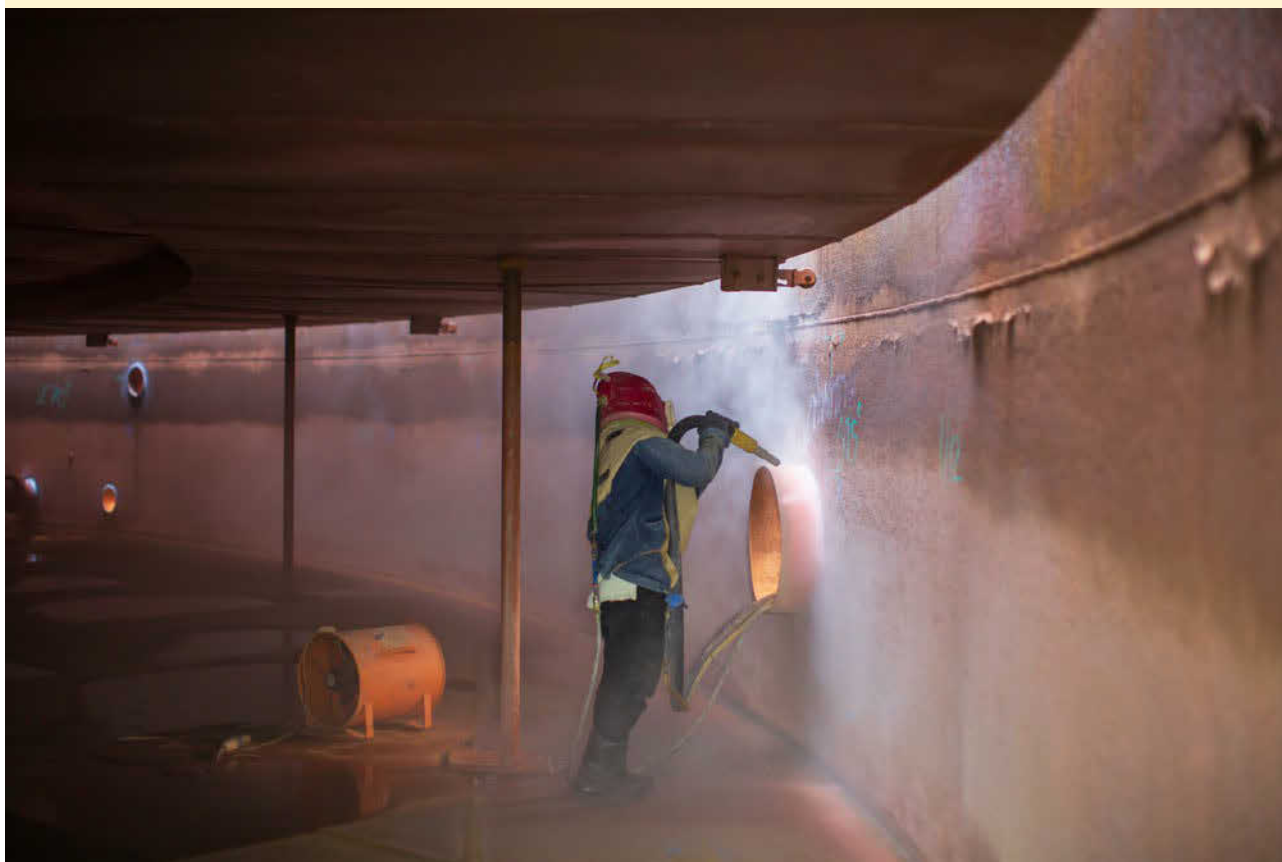
Figure 11-1: Worker removing paint inside of a fuel storage tank using blasting grit

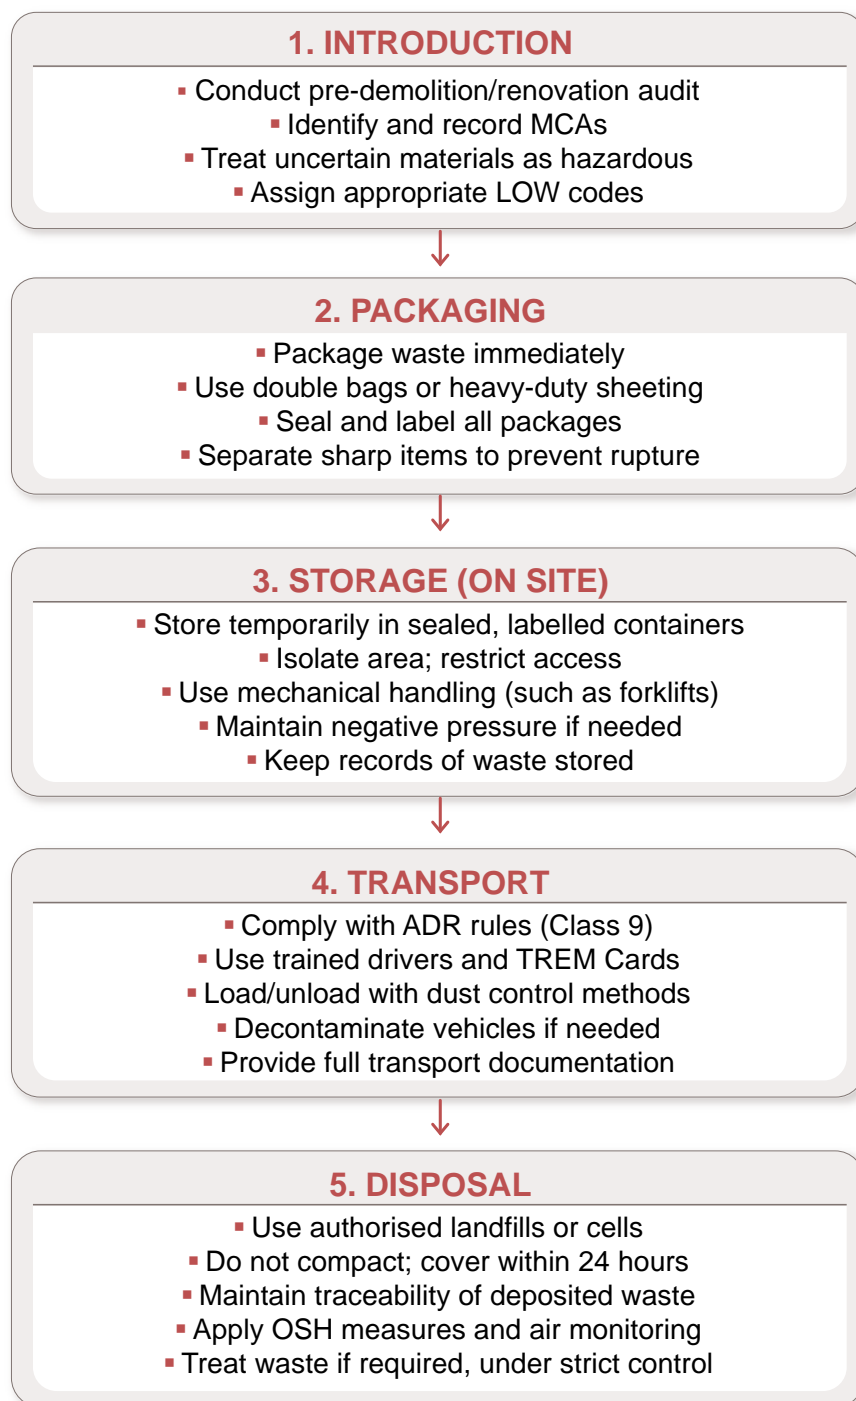
Figure 12-1: WCA management process

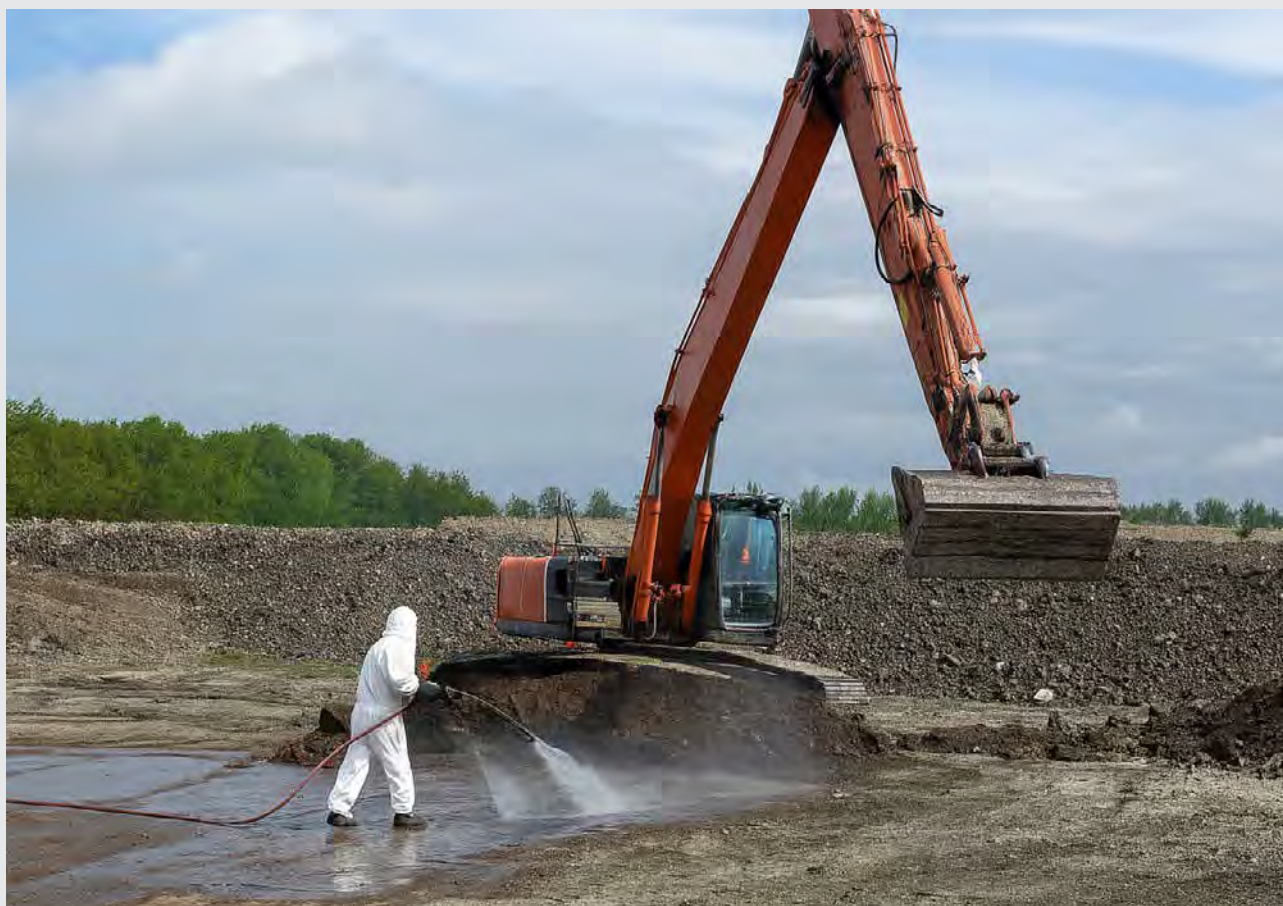
Figure 12-2: Wetting of WCA to prevent dust

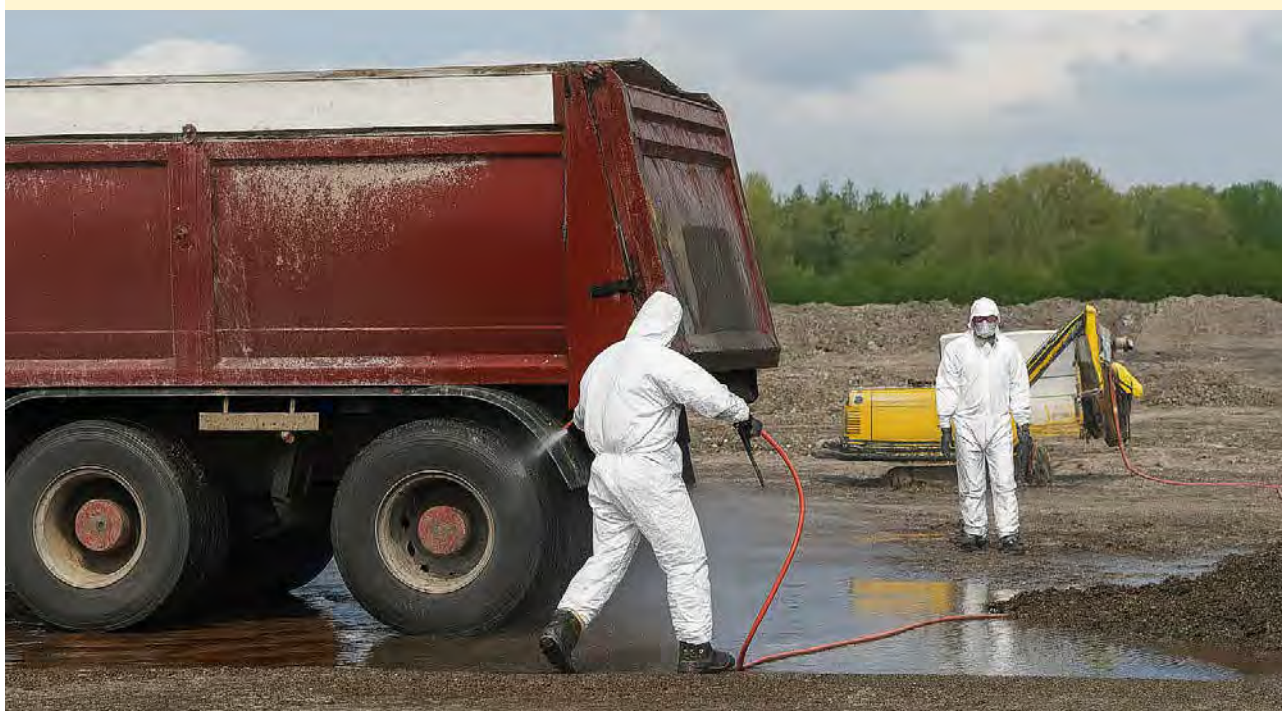
Figure 12-4: Vehicle cleaning

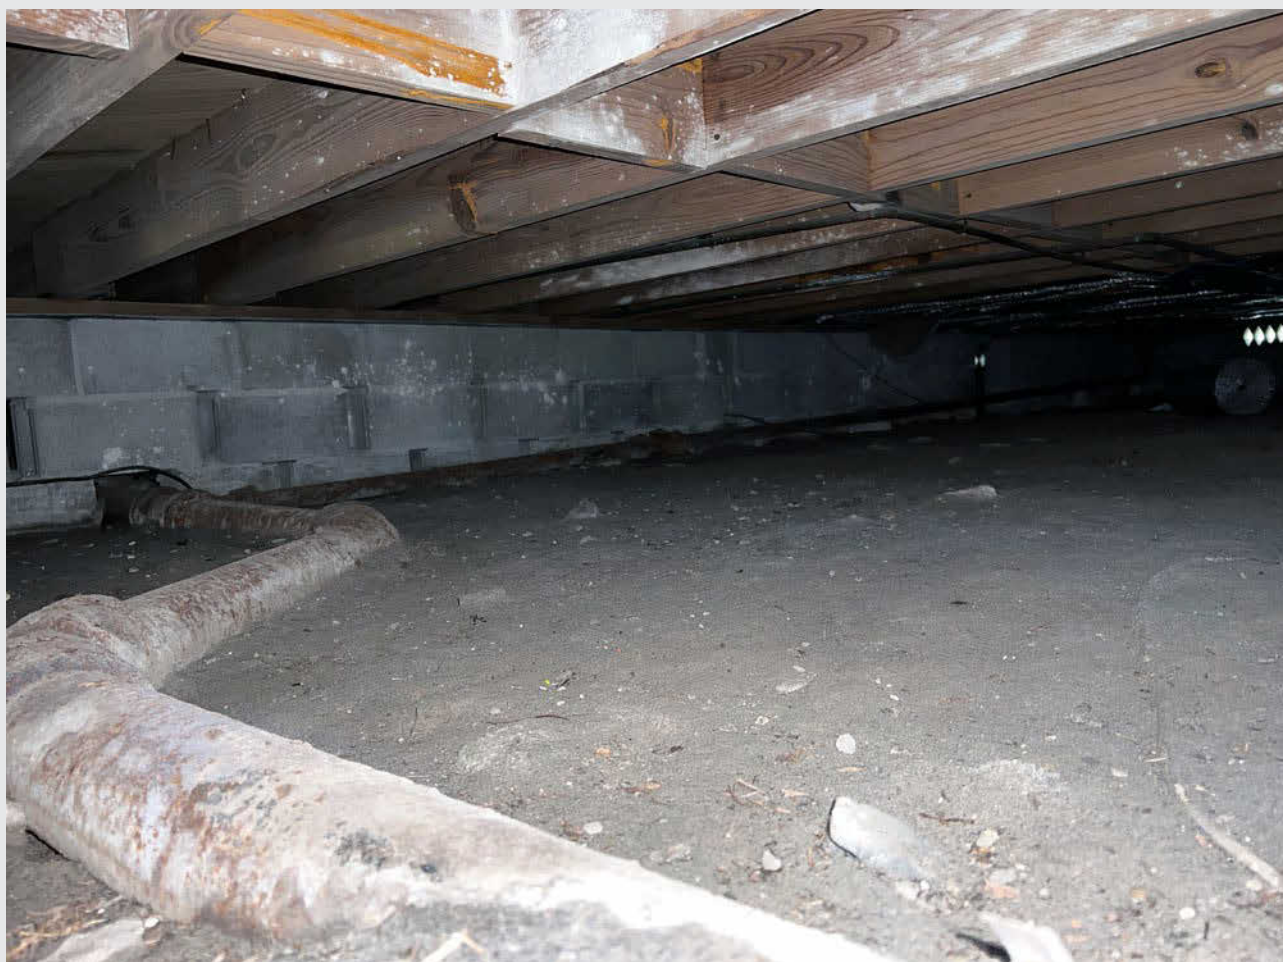
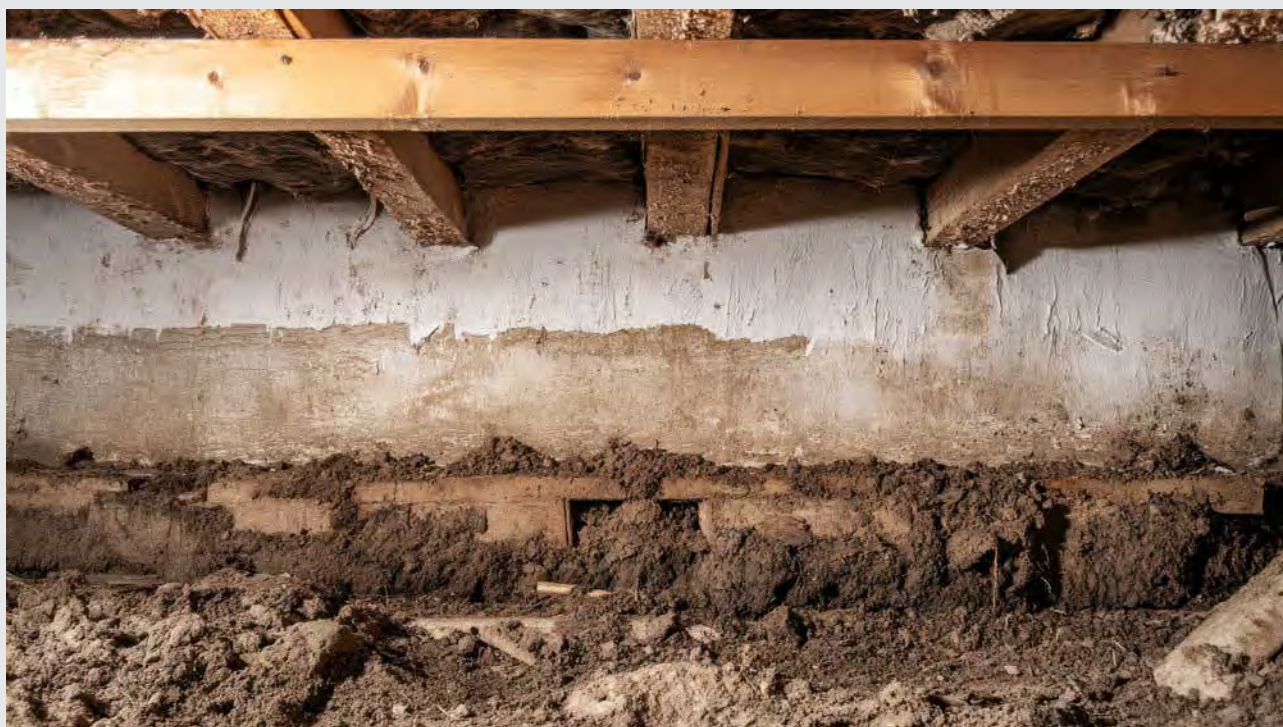
Figure 13-3: Work in crawl spaces

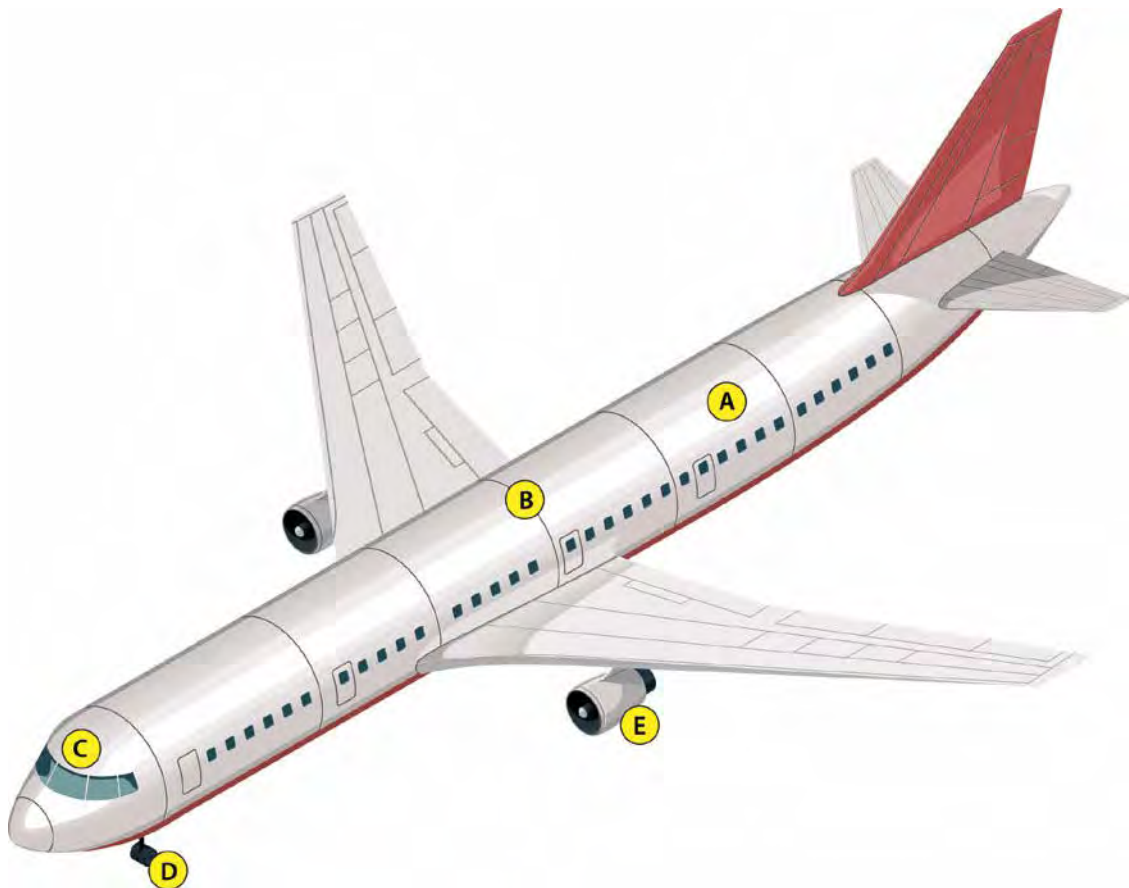
Figure 14-5: Aircraft – where asbestos might be found (non-exhaustive)

A: Fuselage

B: Air conditioning

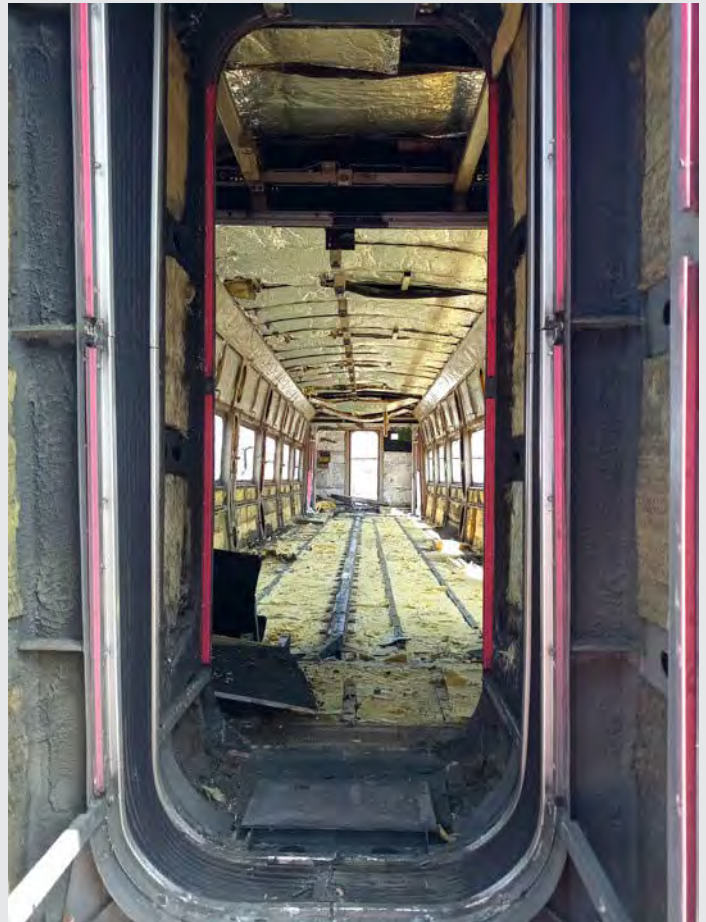
Figure 14-7: Train carriage following the removal of non-hazardous components, awaiting asbestos removal at a train dismantling facility in France

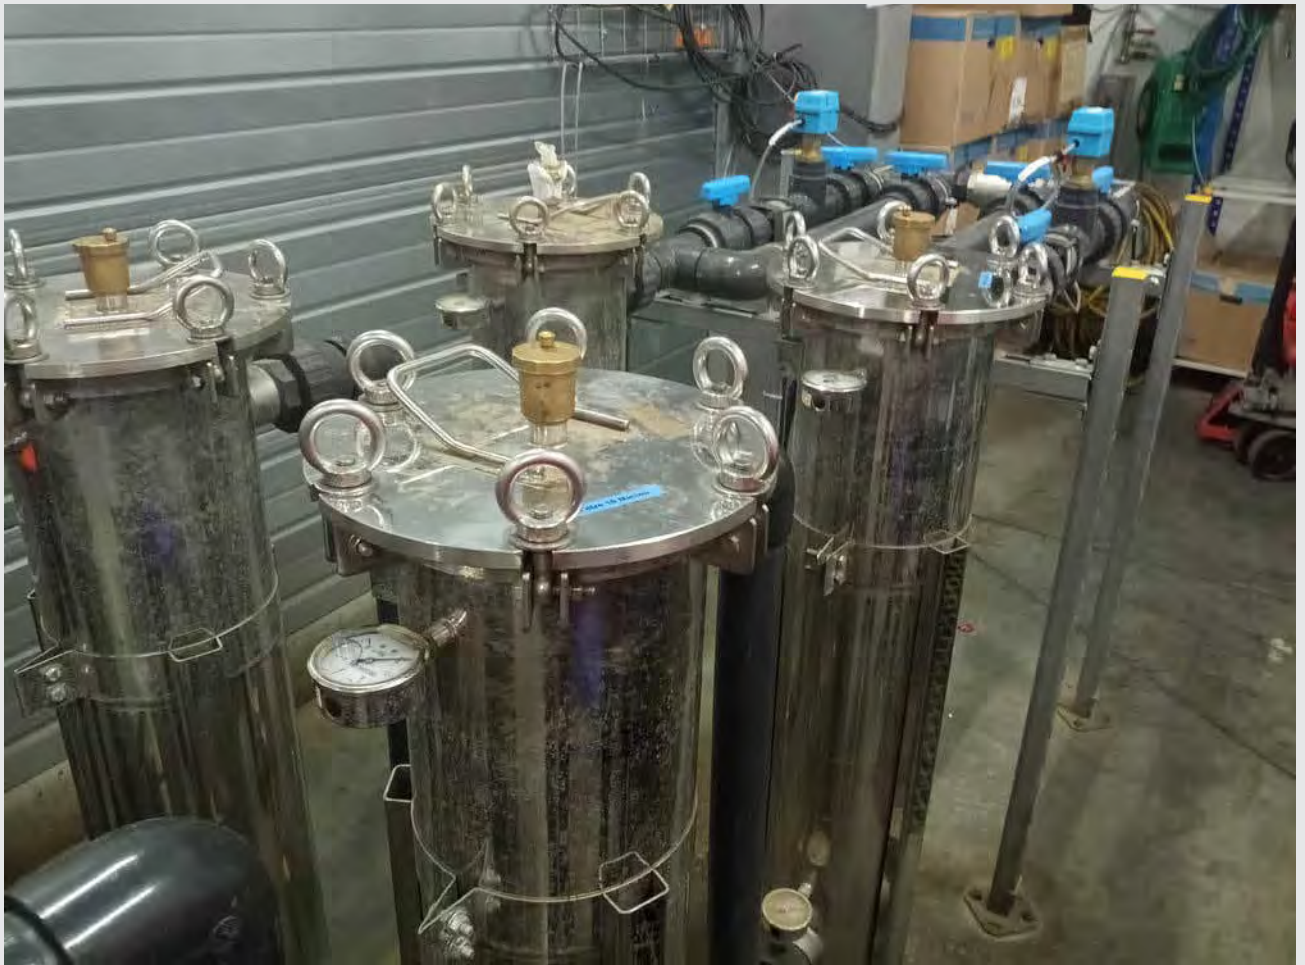
Figure 14-9: Filters to remove asbestos fibres from waste water at a train dismantling facility in France

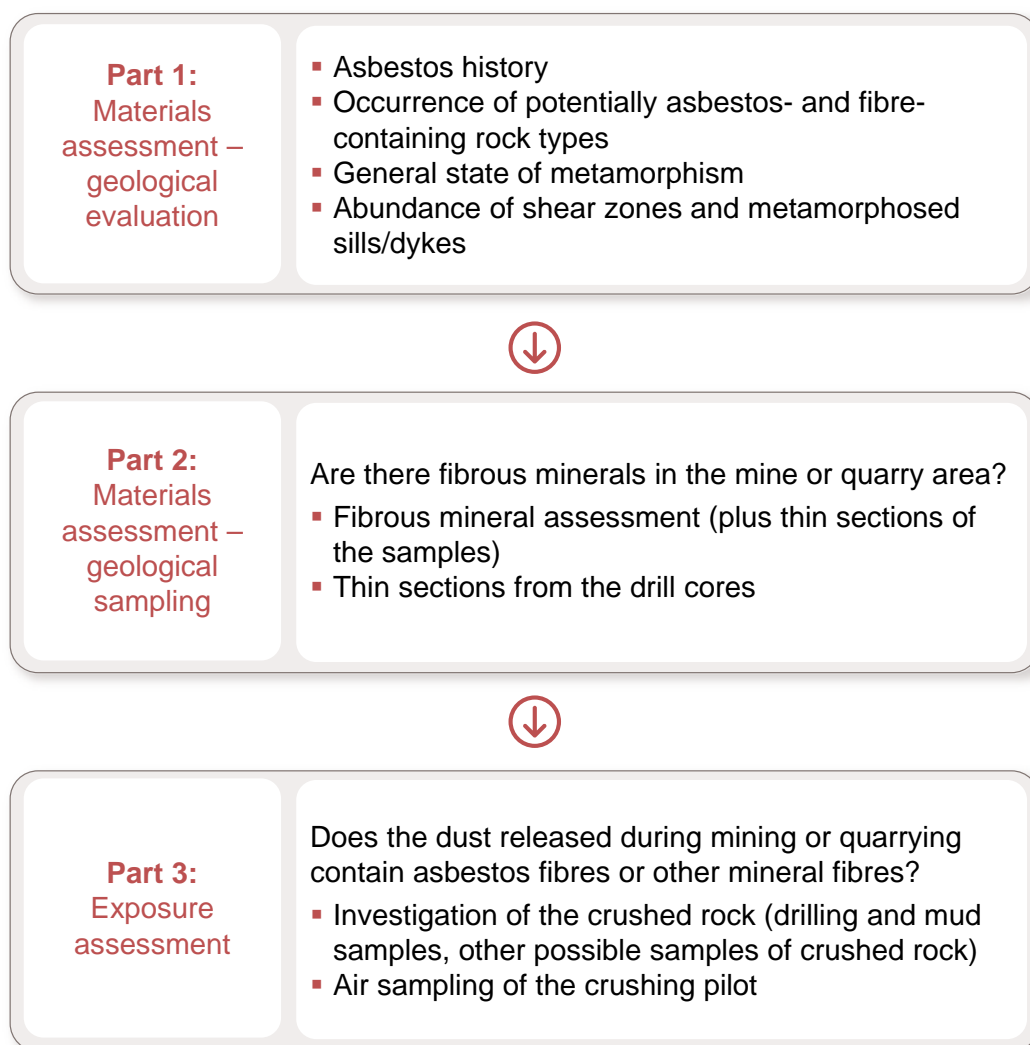
Figure 15-1: Flow chart of the three steps in risk assessment for a mine or quarry

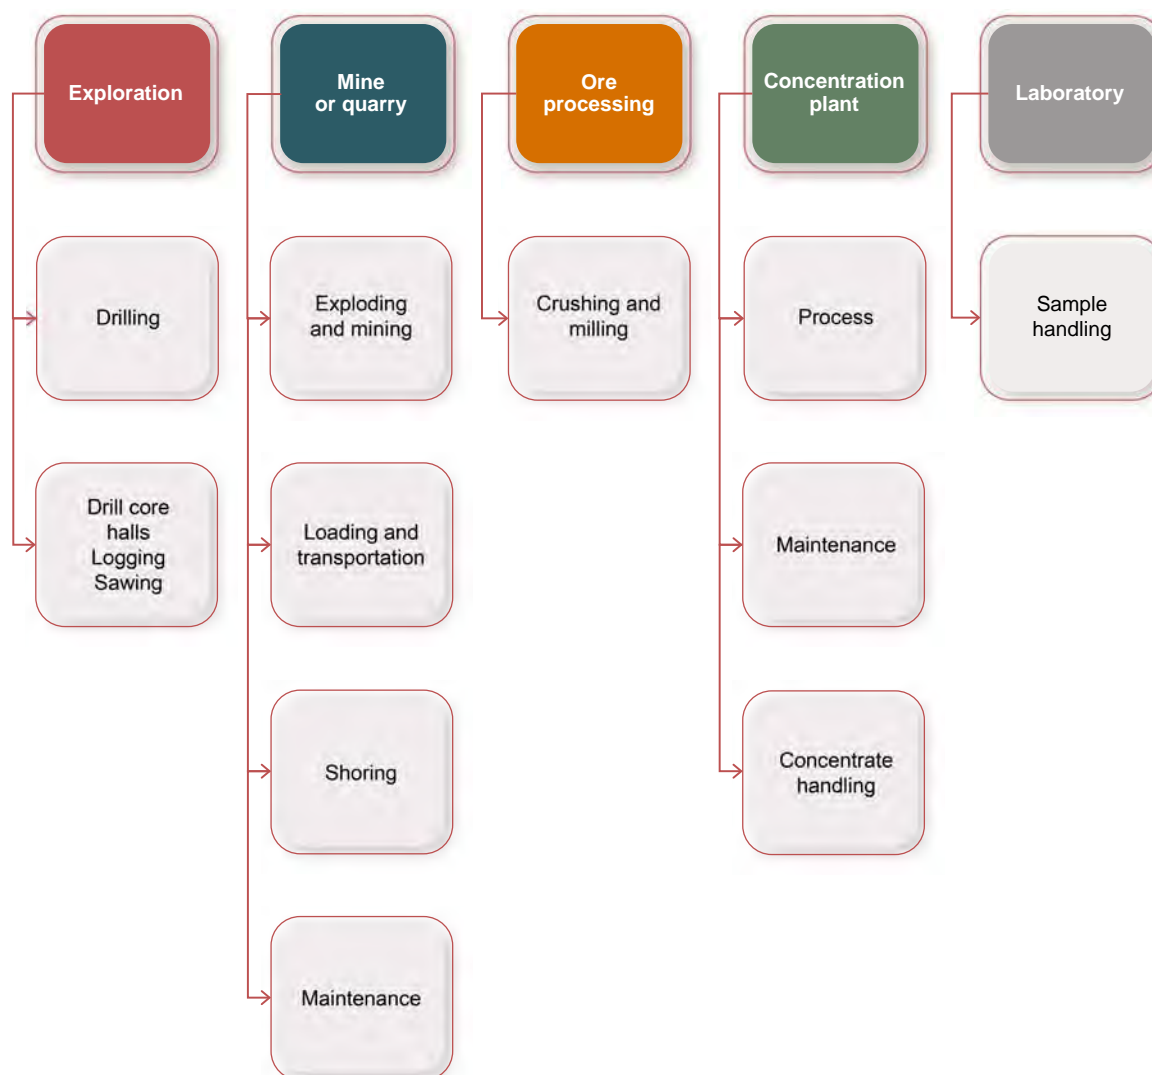
Figure 15-2: Division of mining or quarrying operations into measurement compartments and areas
