EUROPEAN
COMMISSION

**on supporting the implementation of Directive 2009/148/EC on the protection of workers
from the risks related to exposure to asbestos at work as amended by Directive
2023/2668**

Guidelines for **managing asbestos related health and safety risks** at work

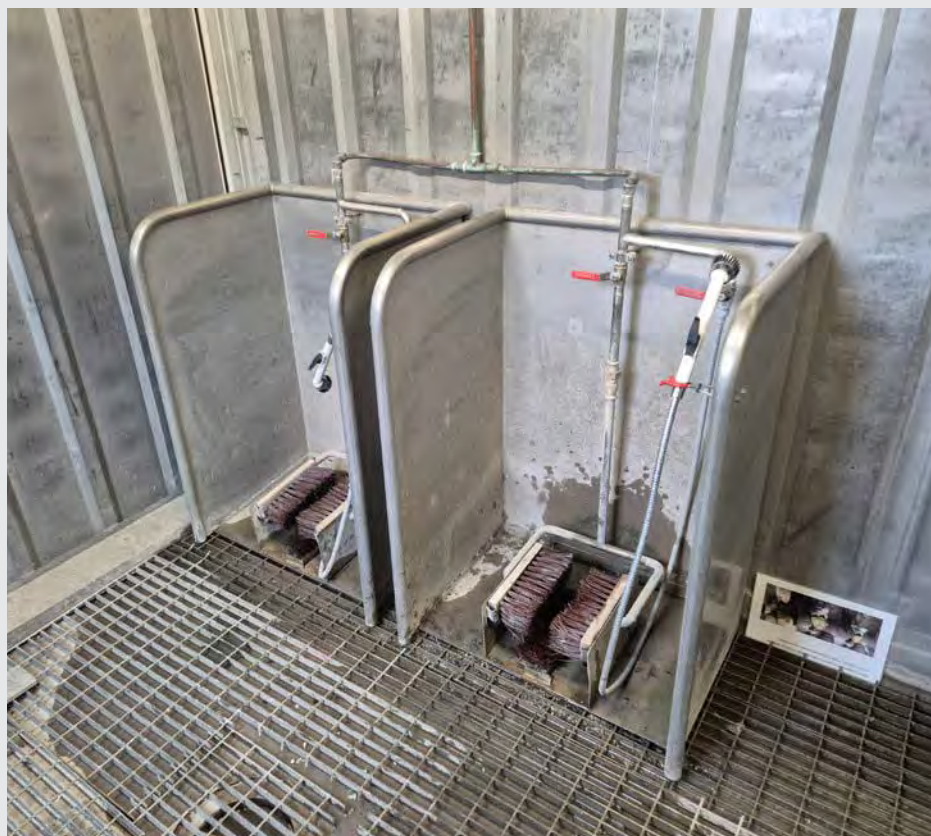
Figure 15-3: Footwear washing facilities inside a decontamination chamber

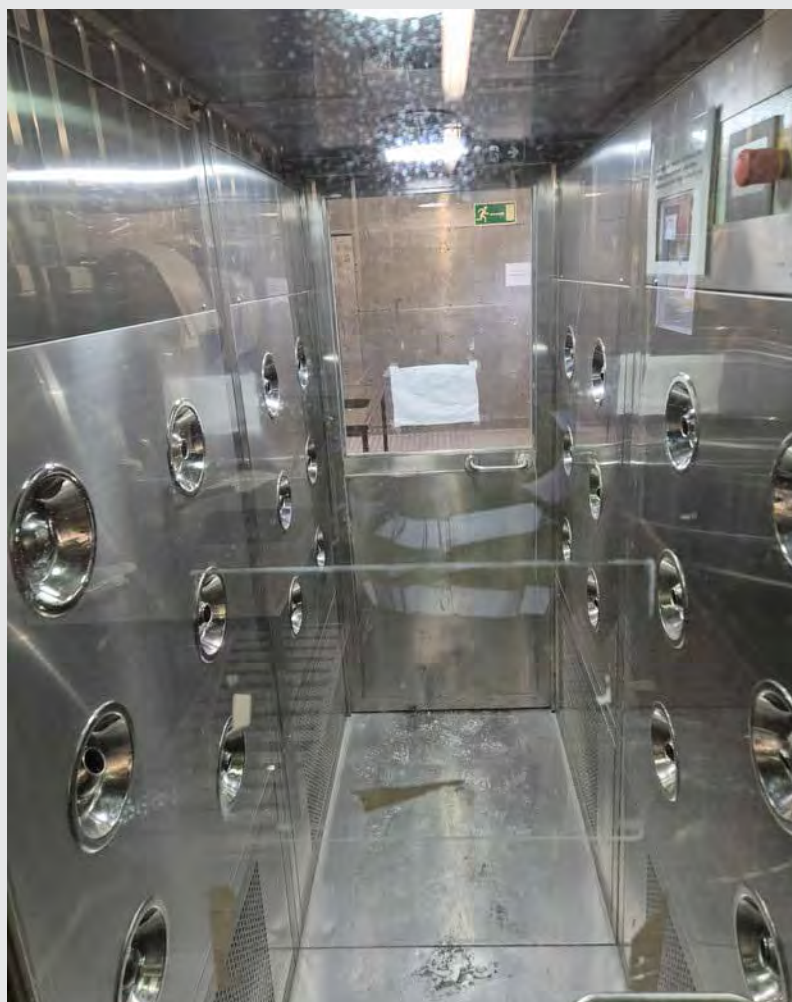
Figure 15-4: In a decontamination chamber, air jets can be used in an air lock to remove any remaining dust from PPE after vacuuming, by circulating air downwards

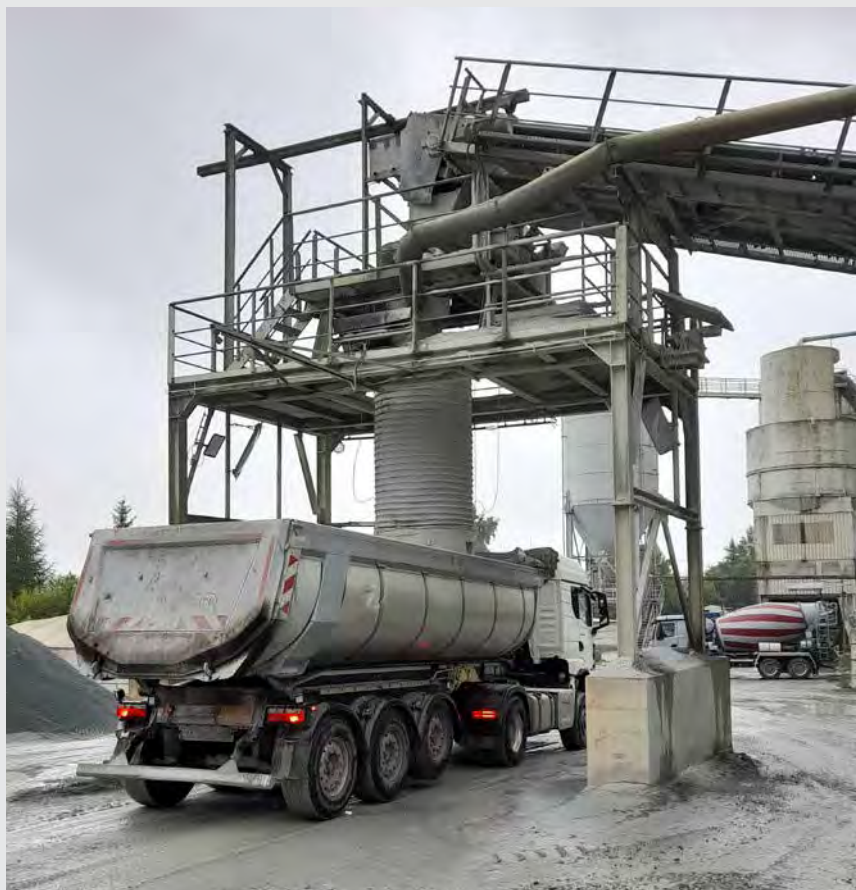
Figure 15-5: Height-adjustable truck-loading spout with dustproof skirt

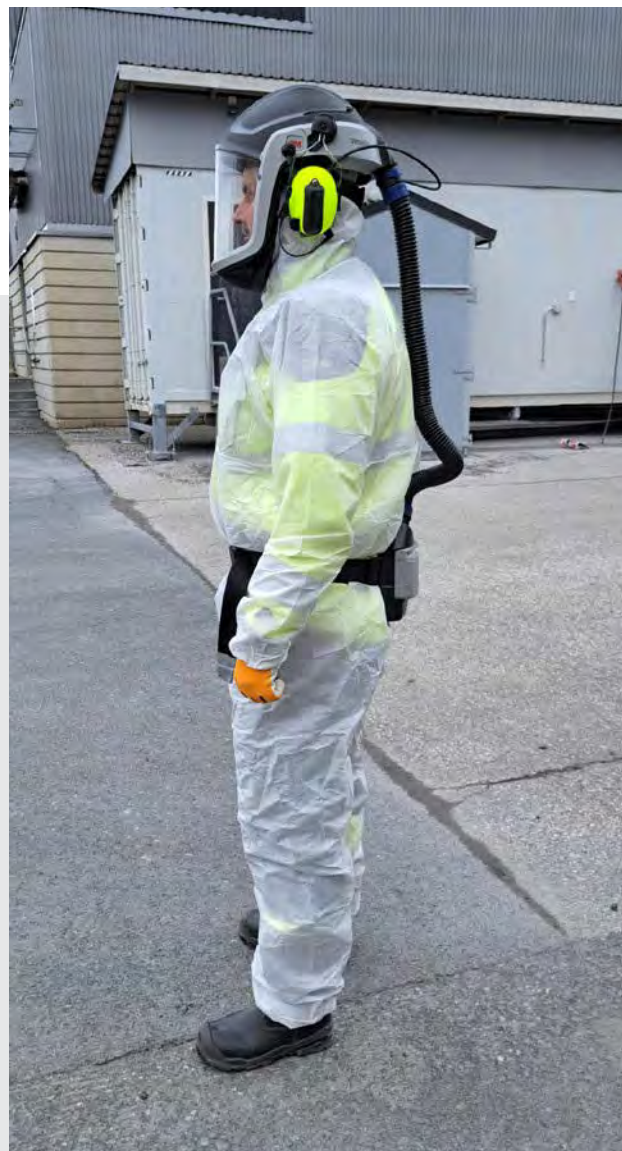
Figure 15-7: PPE for a mine worker, including an RPD

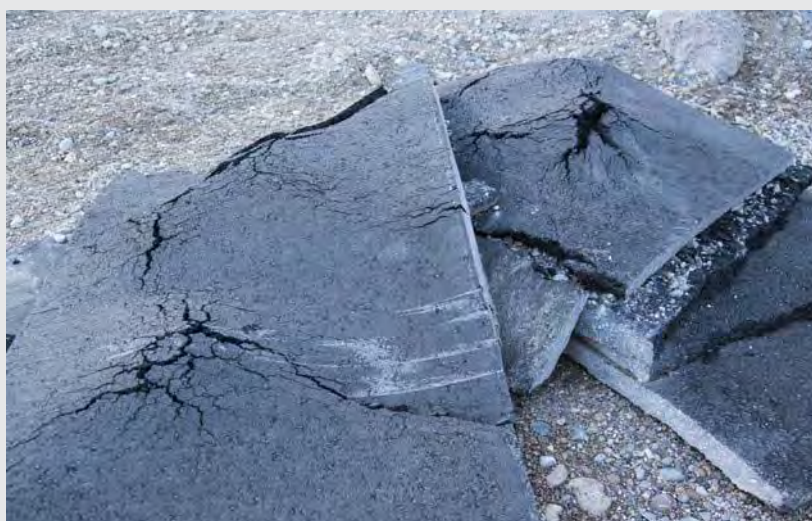
Figure 16-1: Asphalt containing asbestos

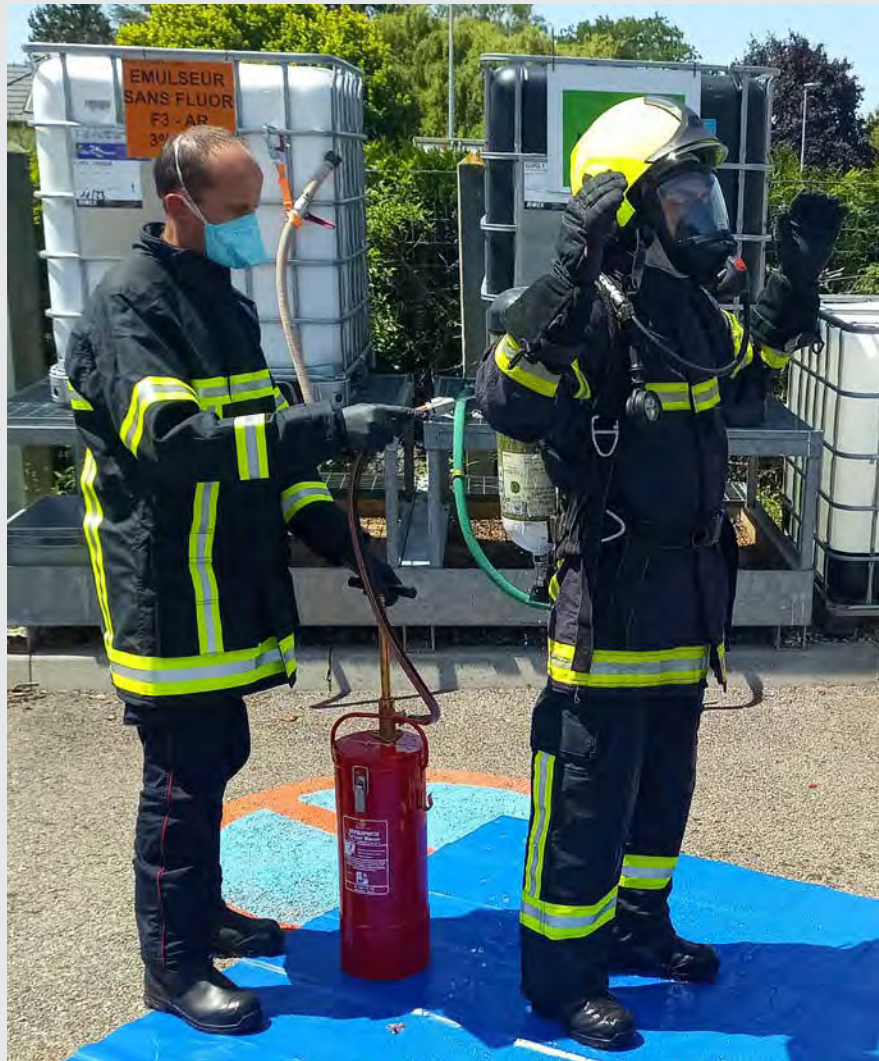
Figure 17-1: A firefighter wearing thermal protective PPE and a self-contained breathing apparatus (SCBA), undergoing the initial stage of asbestos decontamination at the fire site

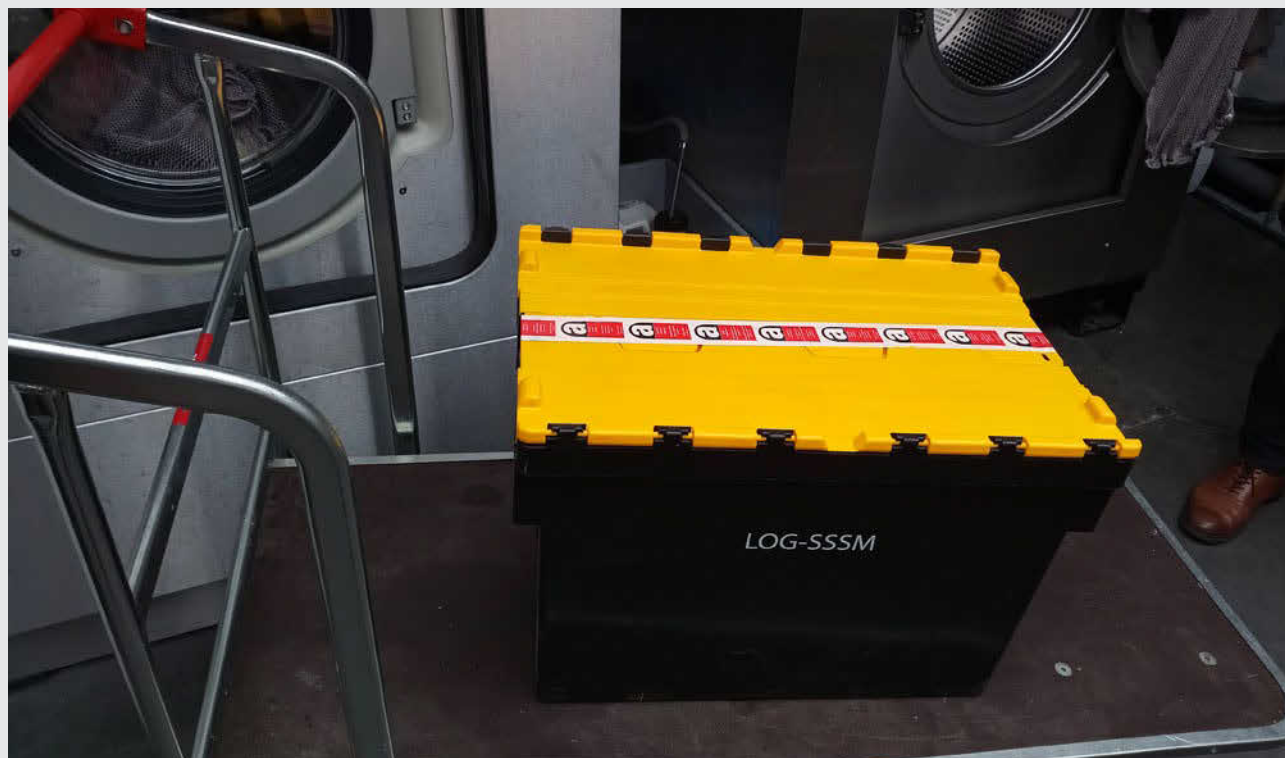
Figure 17-2: Sealed box containing asbestos-contaminated clothing and equipment for thorough cleaning at the fire station

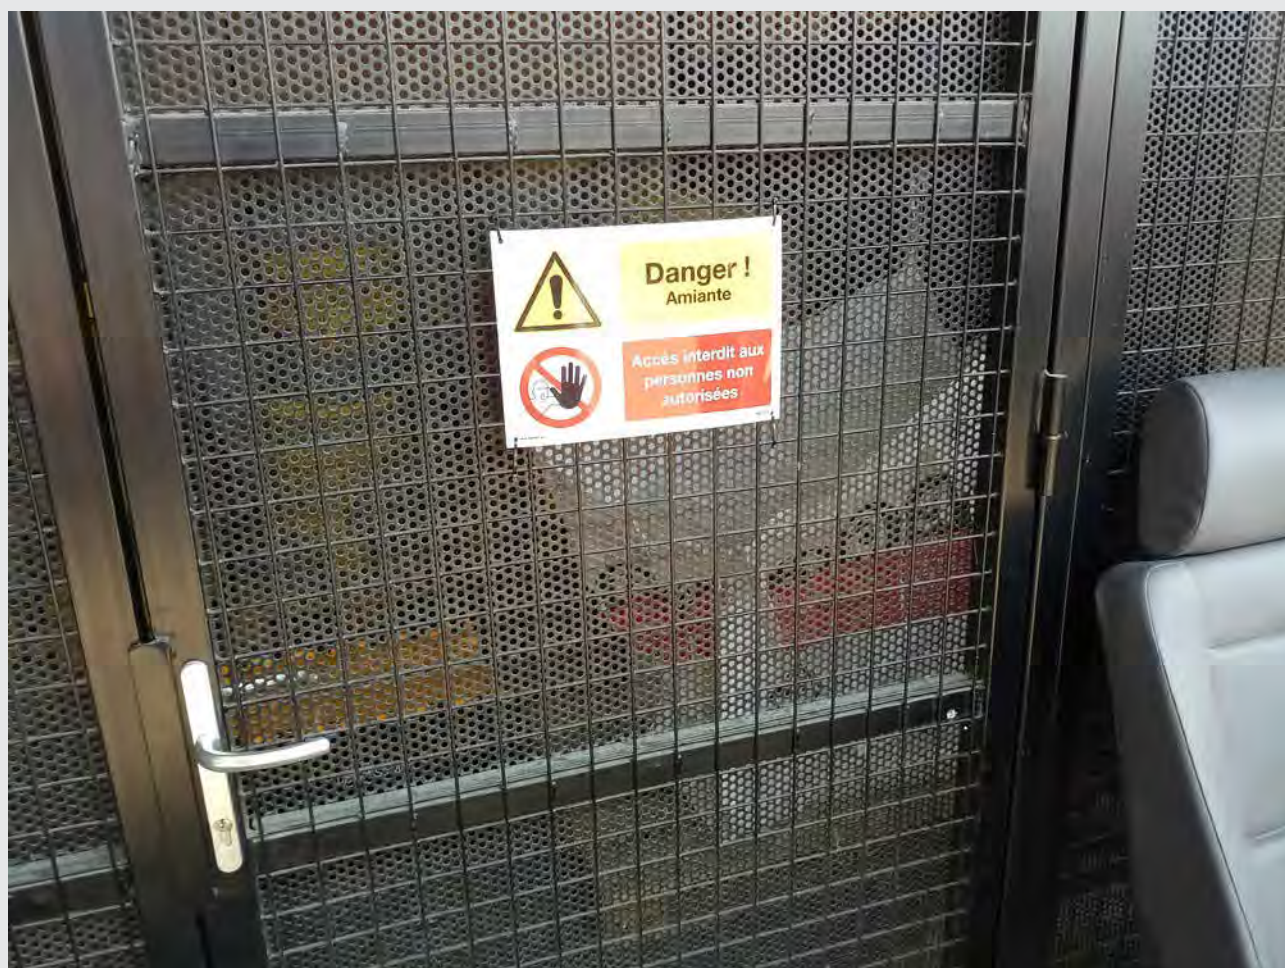
Figure 17-3: WCA from decontamination at a fire station stored in a secure area before appropriate disposal

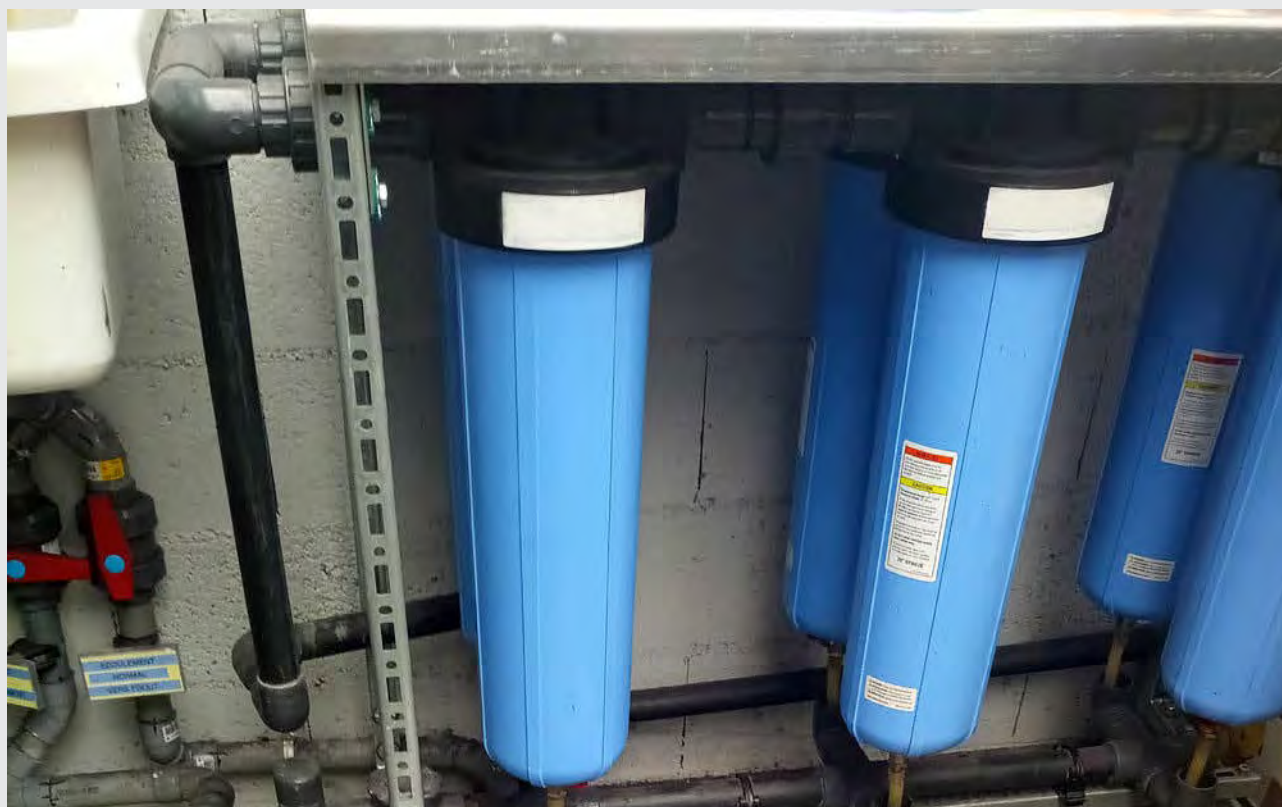
Figure 17-4: Filters installed in a fire station to remove asbestos fibres from waste water
